SOUTHEASTER, INC. STRUCTURAL INTEGRITY RESERVE STUDY (SIRS)

For 30-Year Projection Period: FY 2024 through FY 2054

Reference #: 1379.24

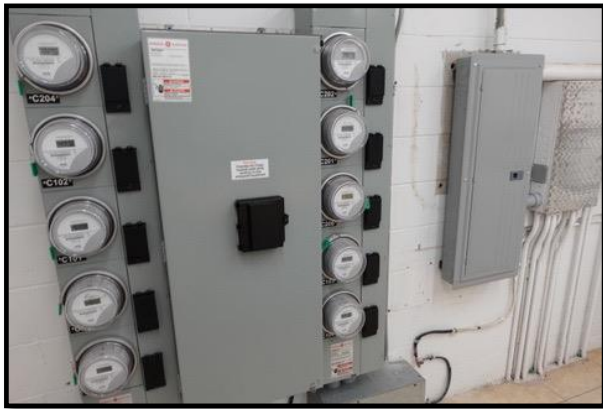
Figure 1 – Meter Bank

The Association maintains the common electrical systems. The common area electrical panels are in satisfactory operational condition and range in age. Electrical systems can have a long useful life of up to 75 years and beyond. Not all components will fail simultaneously and therefore periodic repairs and partial replacements are likely as the system ages. Southeaster should budget for partial replacements by 2034 and every 10 years thereafter. The exact times and costs will vary.

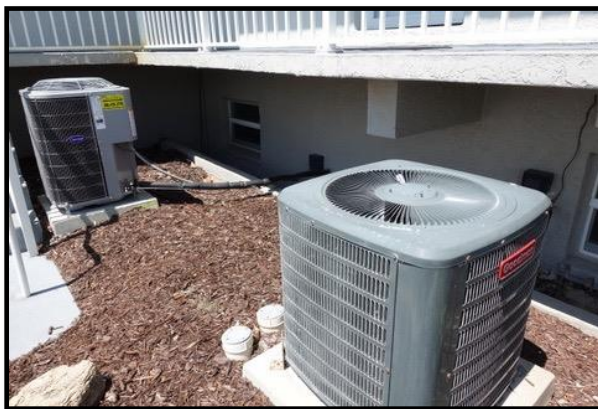
Figure 1 – Condensing Units

The recreational area utilizes two split systems for heating, ventilating and air conditioning. A split system comprises an outdoor condensing unit and an indoor air handling unit. The split systems were operational at the time of inspection.

Split systems have a useful life from 8- to 12-years. Southeaster should budget for replacements by 2031 and every 10 years thereafter. The replacement costs are based on a 14 seasonal energy efficiency ratio (SEER).

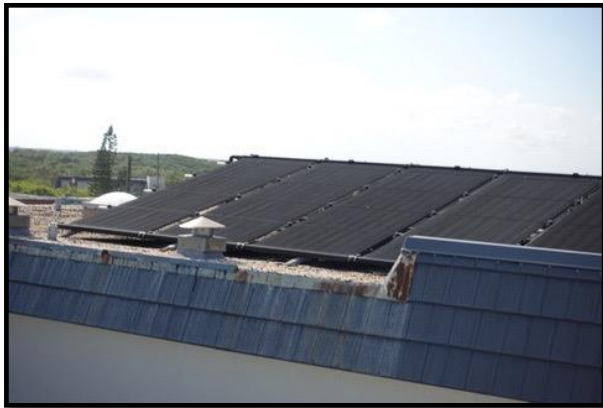
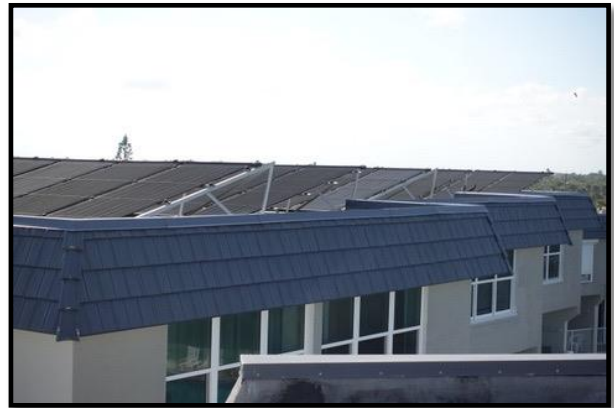
The pool is heated by a solar system located atop Building C. The solar system is in fair reported condition at an age of approximately 18 years. Management reports that Southeaster plans to replace the roof where the solar system is located in the near term. The Association should budget to remove and reset the system in 2025 and again by 2045. The solar system has a useful life of up to 25 years. Southeaster should also budget for replacement of the solar system by 2031 and again by 2054.

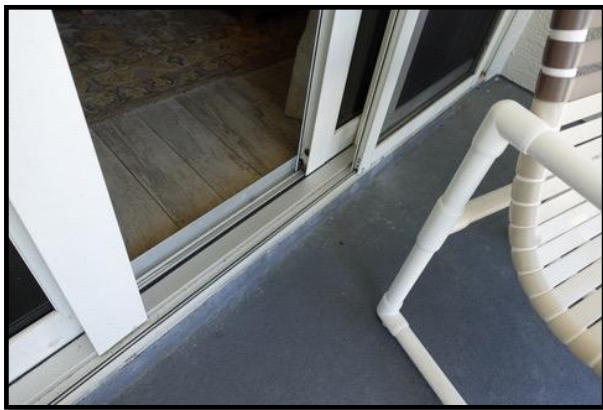
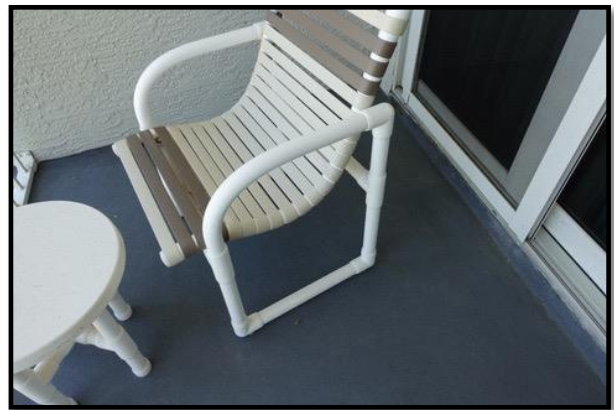
Southeaster maintains balconies that comprise approximately 8,105 square feet of concrete surface. Balconies are structural components that support themselves rather than supporting the building. The balconies are in fair condition overall. Management reports that the Association conducted a concrete restoration in 2008. Balconies have a long useful life with the benefit of periodic maintenance. Concrete cracks and spalling occur from the expansion of the reinforcing steel bars due to corrosion. Concrete corrosion is caused by rainwater and chlorides penetrating the surface of the concrete and contacting the embedded steel reinforcement bars. Failure to maintain the balconies can lead to costly repairs.

Concrete repairs include replacing compromised reinforcing within associated cracks and spalls. Cracks should be repaired with a gravity feed epoxy. Southeaster should consider using a hybrid coating consisting of a urethane base coat with a textured acrylic topcoat. The proper way to apply coatings is to remove and reinstall the railings. Coatings provide the primary protection from the elements and can minimize ongoing cyclic structural concrete damage (spalling) due to corrosion. Waterproof coatings applied to horizontal walking surfaces should meet or exceed the minimum requirements for pedestrian traffic bearing capacity and slip resistance.

The Association should budget for waterproof coating applications, cant bead and partial concrete repairs as needed in 2025 and every 5- to 10-years thereafter in conjunction with paint finish applications. The cant bead is the seal between the wall and floor surfaces. Southeaster should also budget for removal of the existing coatings in 2025 and every 10- to 15-years thereafter.

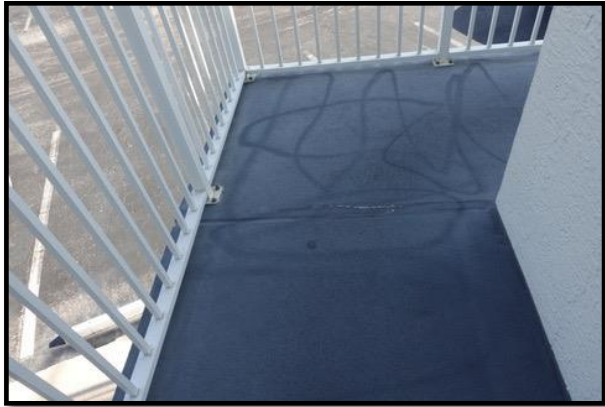
Southeaster maintains breezeways that comprise approximately 10,785 square feet of concrete surface. The breezeways are original and in good condition overall. Breezeways have a long useful life with the benefit of periodic maintenance. Concrete cracks and spalling occur from the expansion of the reinforcing steel bars due to corrosion. Concrete corrosion is caused by rainwater and chlorides penetrating the surface of the concrete and contacting the embedded steel reinforcement bars. Failure to maintain the breezeways can lead to costly repairs. Coatings provide the primary protection from the elements and can minimize ongoing cyclic structural concrete damage (spalling) due to corrosion. The Association should budget for waterproof coating applications and partial repairs as needed in 2025 and every 5- to 10-years thereafter in conjunction

Figure 1 – Surface Crack

with paint finish applications. Southeaster should also budget for removal of the existing coatings in 2025 and every 10- to 15-years thereafter.

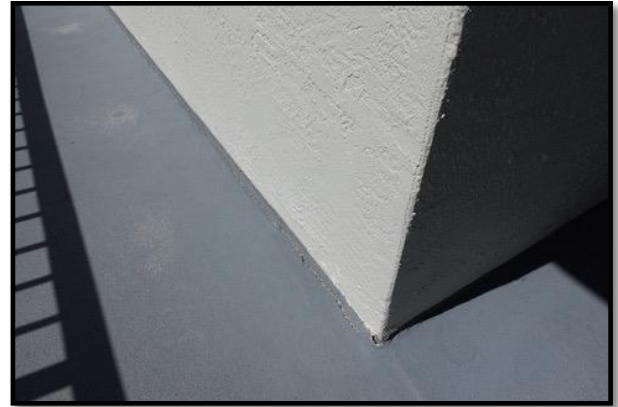
Figure 2 – Cracked Wall to Floor Seal

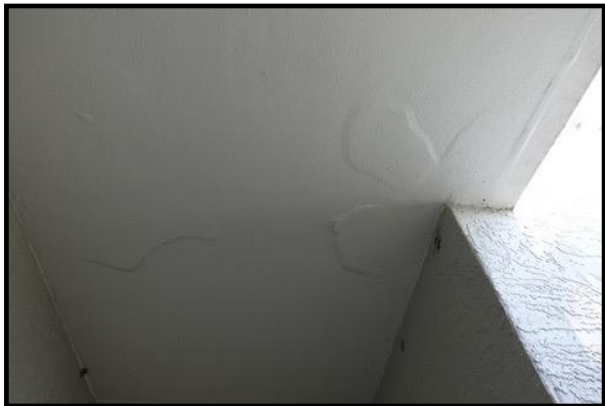
Concrete is strong in compression and weak in tension and therefore requires steel reinforcing. Concrete corrosion is caused by rainwater and chlorides (salt) getting into the concrete down to the level of the steel. The Association is currently repairing a staircase column located between Buildings E and F. The known estimate of cost is included in 2024. A budgetary allowance is also included in 2025 until further information is provided by the engineer.

Figure 1 – Breezeway Side Ceiling Delamination

International Concrete Repair Institute Guidelines, ACI Building Code 562. The estimate of cost and times of restoration projects will vary based on natural forces and hidden underlying deterioration. Since concrete restoration costs are unknown until it happens, the Association should fund overages through a special assessment as needed.

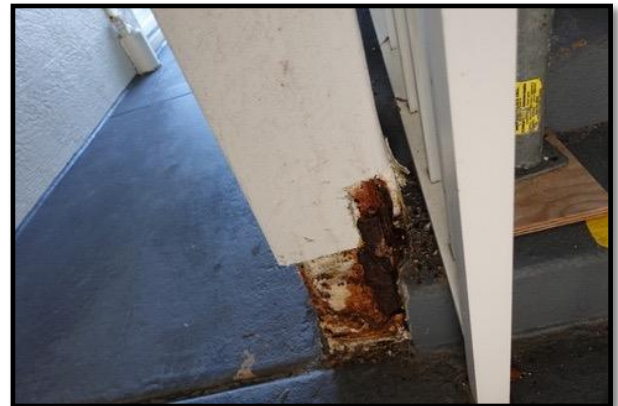
Figure 2 – Staircase Column Corrosion

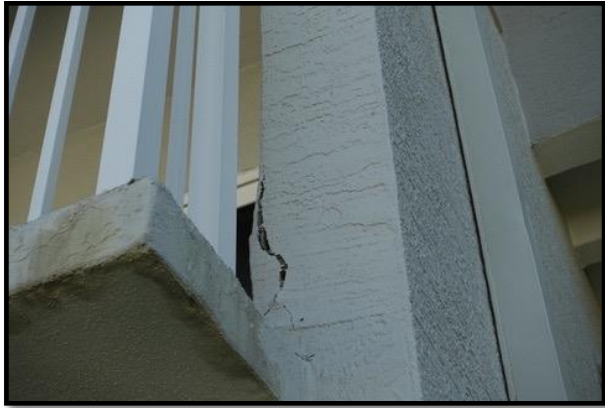
Concrete spalling occurs under a sliding glass door due to long term water intrusion at the door track. This spalling can encroach on the interior space. Once the corrosion process has been initiated, the Association should budget an allowance for partial repairs in 2025 and every 5- to 10-years thereafter in conjunction with paint finish applications. Effective corrosion mitigation can delay and minimize future concrete spalling. Concrete repairs should be in accordance with the

Figure 3 – Significant Wall Crack

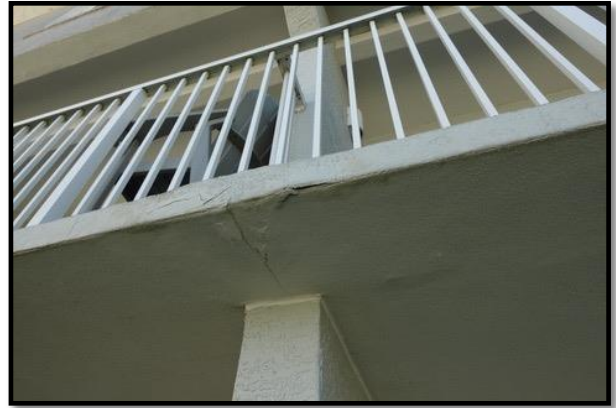
Figure 4 – Balcony Cracks

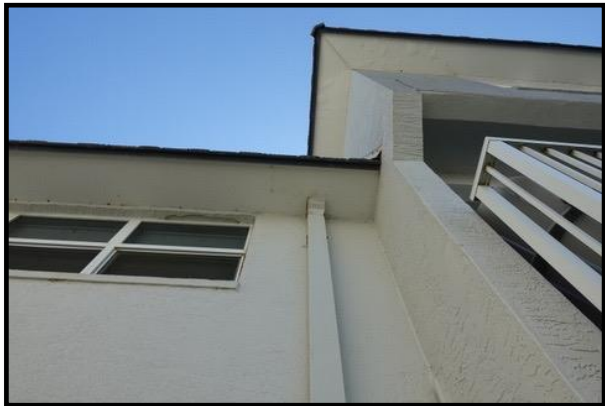
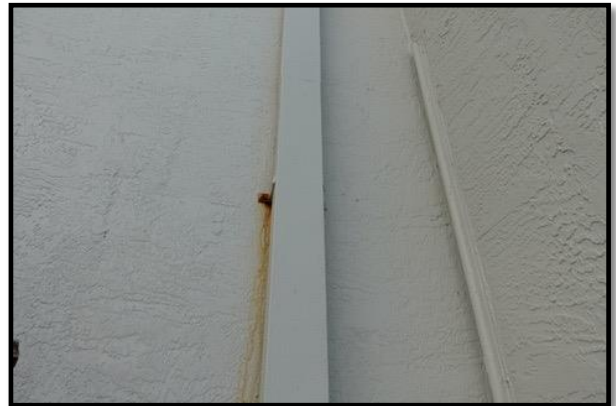
Southeaster utilizes approximately 525 linear feet of downspouts that are designed to collect rainwater from the roofs and shed the water away from the buildings. The downspouts are in good overall condition at an age of approximately five years. Downspouts have a useful life of up to 25 years. The Association should budget for replacements by 2044. The Association should ensure the water is directed away from foundations.

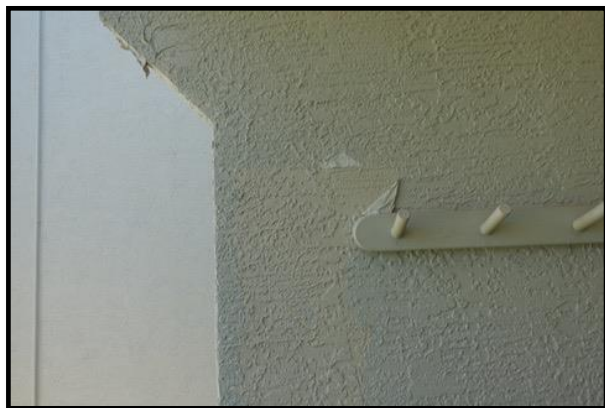
Figure 1 – Peeling and Faded Paint

The paint finishes are in poor overall condition. Management and the Board report that Southeaster plans the next paint finish application in 2024. Paint finishes have a useful life from 5- to 10-years. The Association should plan for weatherizing the window sealants and any exterior penetrations such as hairline cracks as needed in conjunction with paint finish applications. The window sealants should be replaced with a polyurethane sealant and then painted over for protection from UV light degradation. The Association should also plan to have a licensed engineer that specializes in restoration projects to inspect and develop a plan for any repairs prior to paint finish applications. Repairs to the metal supports should be conducted prior to paint.

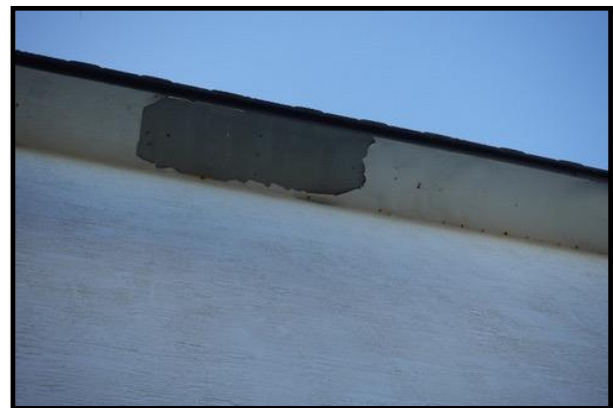
Figure 2 – Chipped Soffit Paint

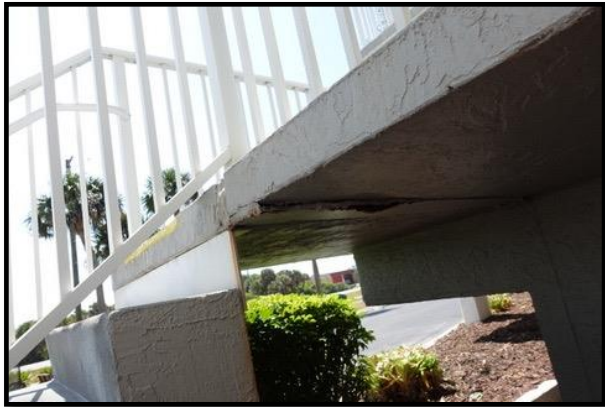
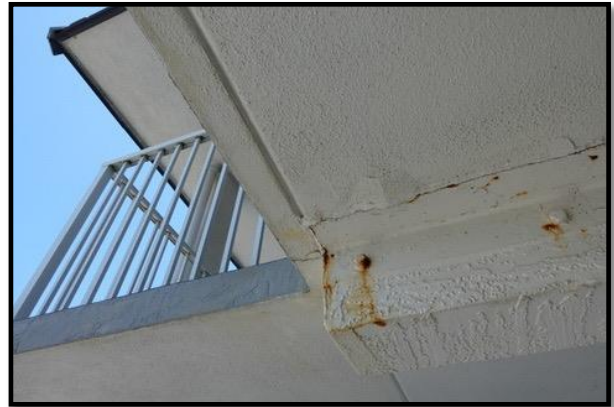
Figure 3 – Metal Support Corrosion

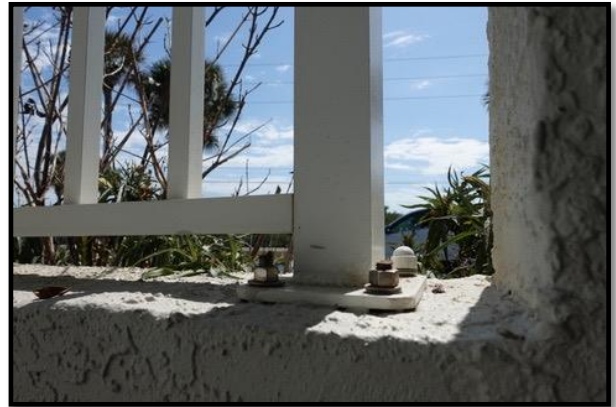
Southeaster can maximize the useful life by repairing connections and fasteners promptly when and if they fail. These activities should be funded through the operating budget on an as needed basis. The Association should budget for railing replacements by 2038. Surface mounted railings should be installed using stainless steel anchors set into predrilled holes and filled with sealant to minimize edge spalling. Southeaster should make sure the stainless-steel fasteners are used with caps for added protection. Areas of missing fastener caps are noted.

Figure 4 – Fastener Caps Missing

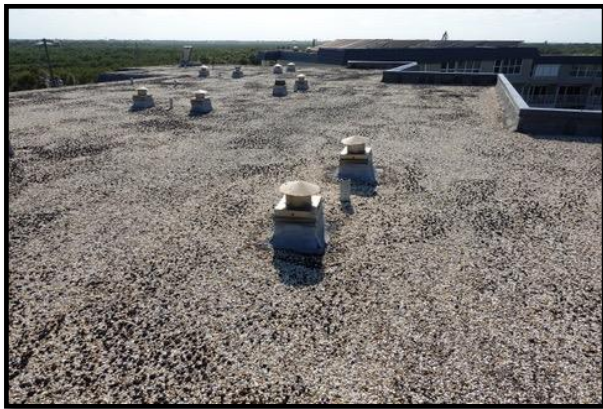
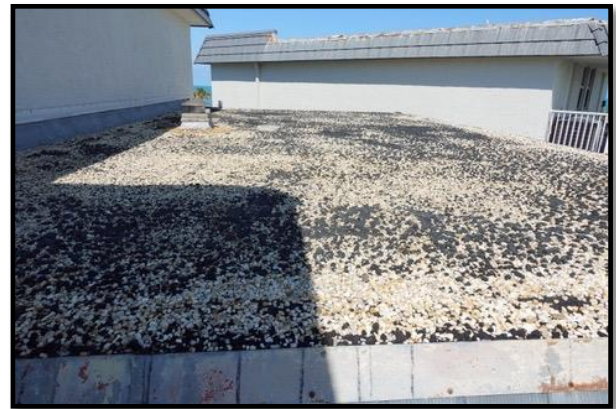
The Association maintains a total of approximately 376 squares of flat roofs. Management reports that Southeaster replaced Building A's flat roof in 2024 with a modified bitumen style roof. The remaining flat roofs comprise a built-up style and are in fair condition at an age of 30 years. Flat roof coverings typically have a useful life from 15- to 20-years.

Exposure to ultraviolet light, heat and weather degrade the membrane overtime. Degradation results in membrane damage from thermal expansion and contraction. Aging of the roof makes the membrane less pliable and difficult to maintain. The most vulnerable parts of a roof are at the perimeters and penetrations such as vents, plumbing stacks and HVAC equipment. Water intrusion can lower insulation R-values and weaken the roof assembly. Ponding water is water that sits on a roof for 24- to 48-hours. Standing water is when water sits on the roof for more than 48 hours.

The Association should budget for replacement of Building A's flat roof by 2044. Southeaster should also budget for replacement of the remaining flat roof systems in 2024 and again by 2044. The Association should look for roof system warranties offered by manufacturers. No Dollar Limit (NDL) warranties include roof leaks caused by defects in labor or materials. Interim annual inspections are recommended funded through the operating budget.

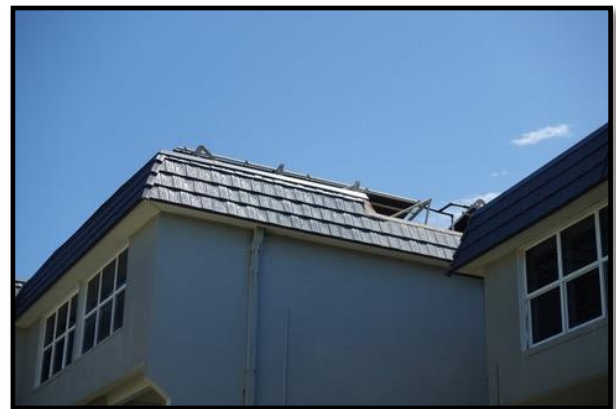
Figure 2 – Existing Mansard

The mansard roofs are in fair to poor overall condition at an age of 16 years. Management reports that the Association plans to replace the mansard roofs in the near term. Mansard roofs have a useful life of up to 35 years.

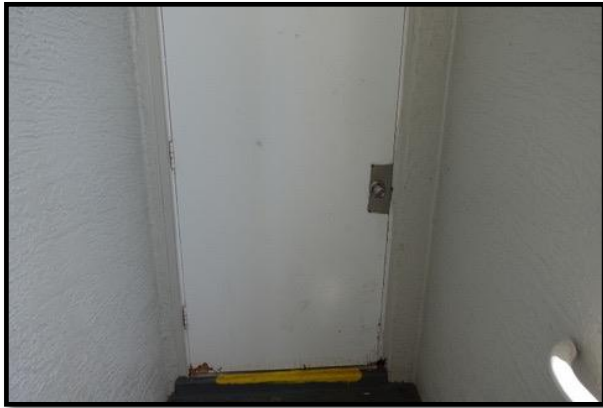
The common windows and doors comprise approximately 460 square feet. These windows are in fair overall condition at various ages. Windows and doors have a useful life of up to 40 years. Based on the varied ages, the Association should budget for phased replacements of the common windows and doors every 10 years beginning in 2029. The estimate of cost is based on a fire rated self-closing door. The windows should meet the Florida Building Code for impact resistance.

Figure 1 – Wood Door Rot

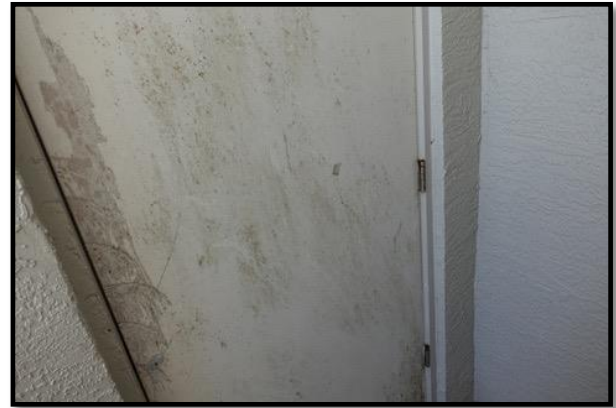
Figure 2 – Poor Door Finish

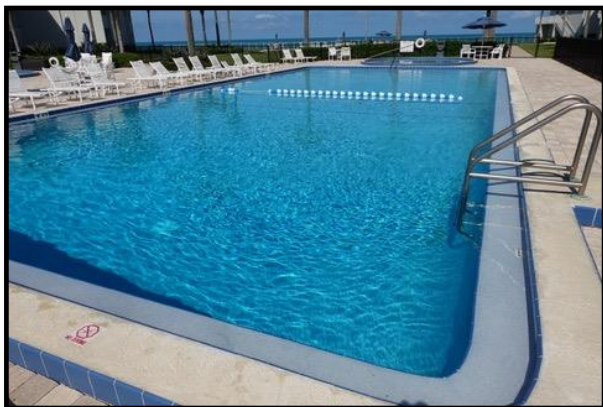
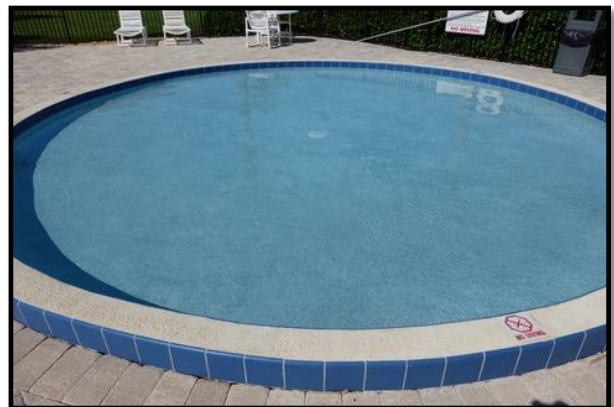
The finish at the pool wall and floor surfaces is in fair overall condition. The ages are unknown. Pool finishes have an anticipated useful life from 10- to 15-years. The Association should budget for resurfacing of the wall and floor areas, as well as replacement of the waterline tile, in 2025 and every 12 years thereafter. Typically, minor upgrades will be needed to bring the pool up to current code. Potential repairs to the underlying pool structure may raise the estimate of cost. The Association should ensure that bidding contractors have an active license with a “CPC” designation.

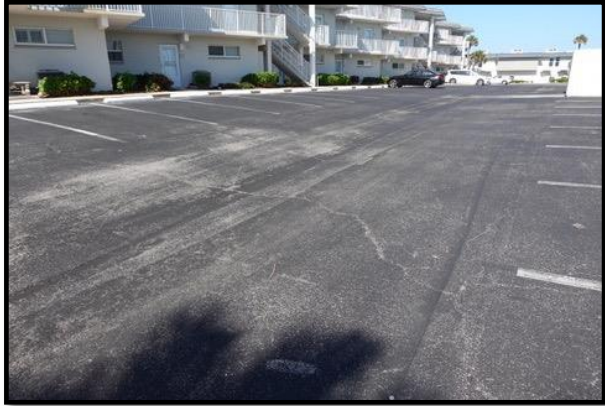
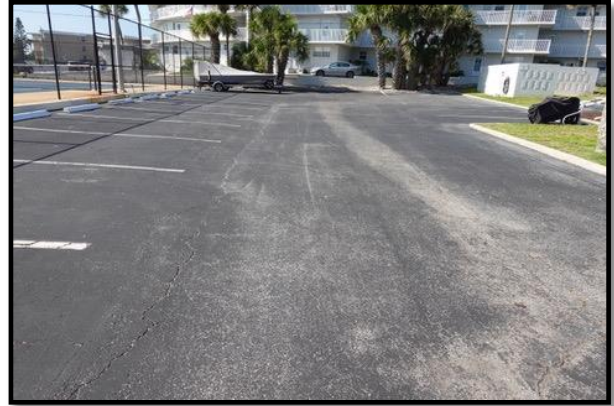
The Association maintains approximately 5,580 square yards of asphalt streets and parking areas. The asphalt pavement is in fair overall condition. The age is unknown. Asphalt pavement comprises multiple layers. Typically, the top layer or surface course deteriorates over time and can be milled or removed and overlaid or replaced. The following diagram depicts typical pavement layers.

A combination of area patching, crack repair and milling should occur before the overlayment. Areas that exhibit potholes, alligator cracks and areas of pavement that are deteriorated from vehicle fluids should all be repaired prior to overlayment. Area patching may require total replacement of isolated areas of pavement. The base course for residential subdivision roadways designed for light traffic is often six inches thick. The paving contractor should seal all cracks. Crack repair minimizes the chance of underlying cracks coming through the overlayment.

The useful life of the asphalt pavement surface course varies from 15- to 25-years due to design, quality of construction, materials and maintenance. Based on the condition, Southeaster should budget for a mill and overlay of the pavement by 2030. The Association should retain an engineer for quality control.

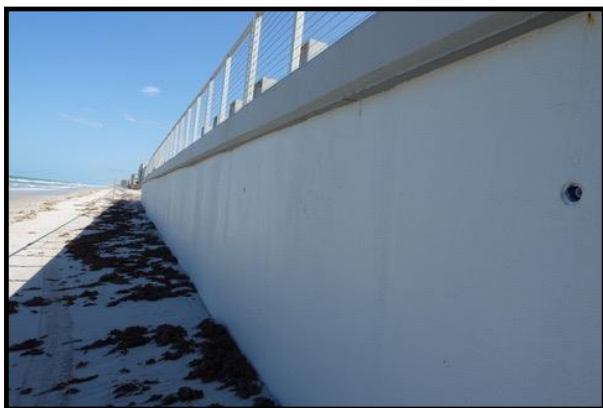
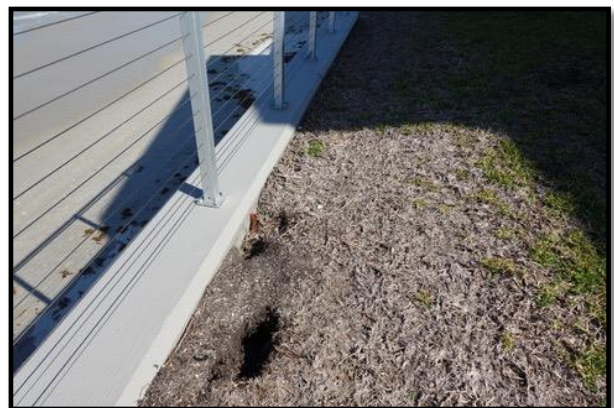
Southeaster maintains approximately 470 linear feet of concrete sea wall. The sea wall is in good overall condition at an age of 22 years. The cap encases the walls anchoring system and transfers the load and is an essential structural component of a sea wall. Sea walls of this type have a long useful life with the benefit of ongoing maintenance. Ongoing maintenance includes power washing and sealing the cap and filling the cracks with.

The Association should budget for replacements of the sea wall by 2052. Interim repairs such as depressions shown above should be funded through the operating budget as needed.
