November 5, 2024 Project No: 24-1396

Subject: Phase 1 Milestone Inspection Report Southeaster Condominium 4841 Saxon Drive, New Smyrna Beach, FL 32169

Southeaster Condominium, New Smyrna Beach, Florida Phase 1 Milestone Inspection Report

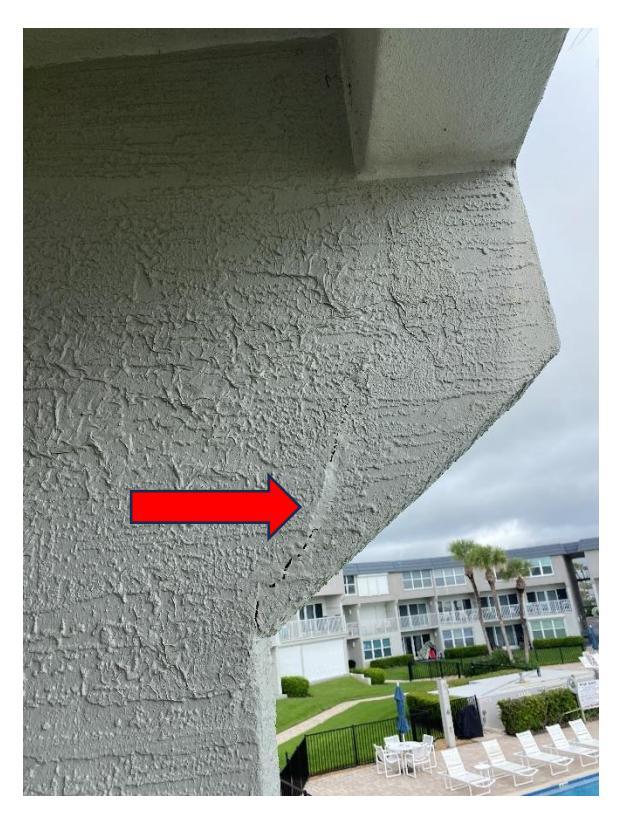
Load Bearing Wall, Columns and Beams: Cracking and concrete spalling damage was identified at the balcony and walkway walls and columns at all buildings. The damage generally was located at the bottom of wall sections and was 1 cubic foot or less in size. The damage was also commonly located at the outside nose of the divider wall between balconies. In total, there is estimated to be 35 cubic feet of wall and column repair.

Photograph #13 – Typical wall spall damage at Building "B" balcony

We recommend the areas of concrete damage be repaired in the next 12 months and before the damage becomes more structurally significant. The repairs should be performed by a Licensed General Contractors who specializes in structural concrete repair. The repairs should also be inspected by an Engineer.

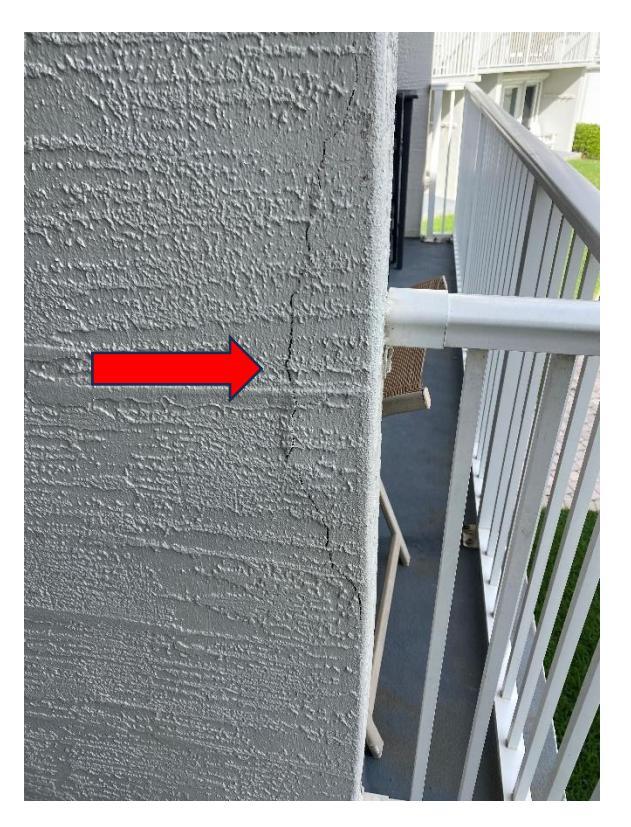
Photograph #14 – Typical wall spall at Building "B" balcony

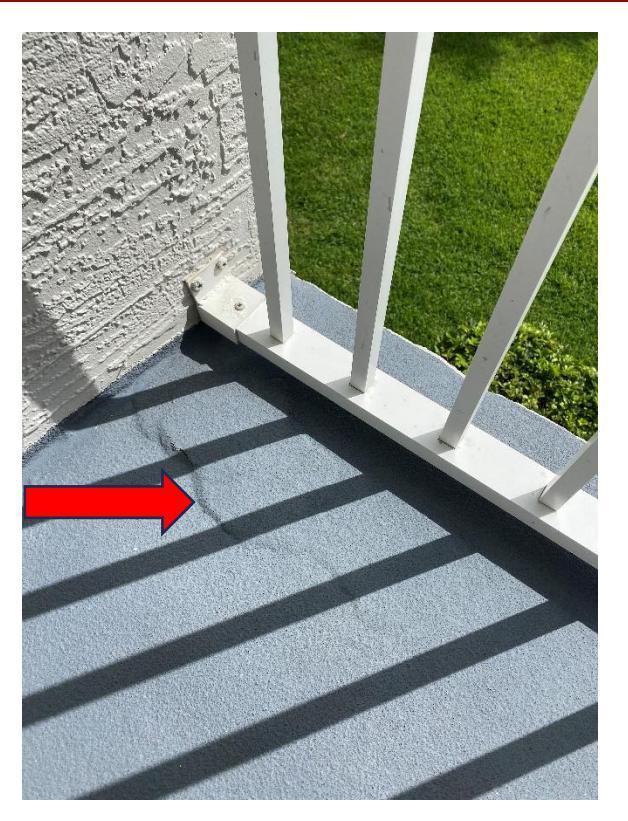
All six buildings had small amounts of concrete spalling damage on the exterior of the structure at the balcony and walkway slabs. In total, there was approximately 75 square feet of damage on the topside of the slabs. It was noted that of that total, 18 square feet was located at Unit D205 balcony and 21 square feet was located on the walkway slabs. Some of the topside damage (mostly the Buildings "D", "E" and "F") is located against sliding glass doors and may ingress below the door threshold.

Photograph #15 – Typical topside slab spall at Building "D" balcony

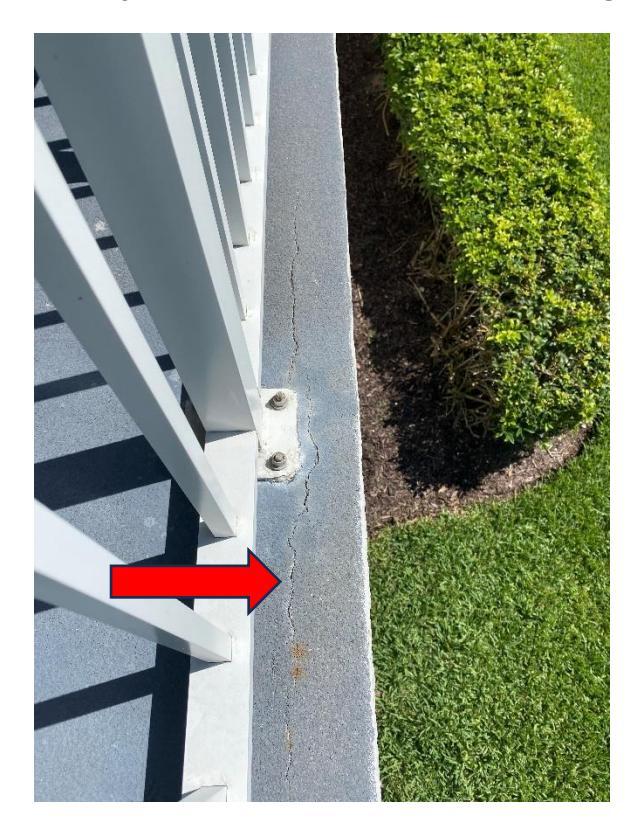
There was approximately 50 square feet of overhead (ceiling) spalling damage on the exterior slabs. Most the damage was located at the walkway slabs and most common at Building "B". There was approximately 45 cubic feet of spalling damage on the exterior slab edges. Over 75% of the slab edge damage was located at the walkway slabs for Buildings "B" and "C".

Photograph #16 – Typical slab edge spall at Building "E" balcony

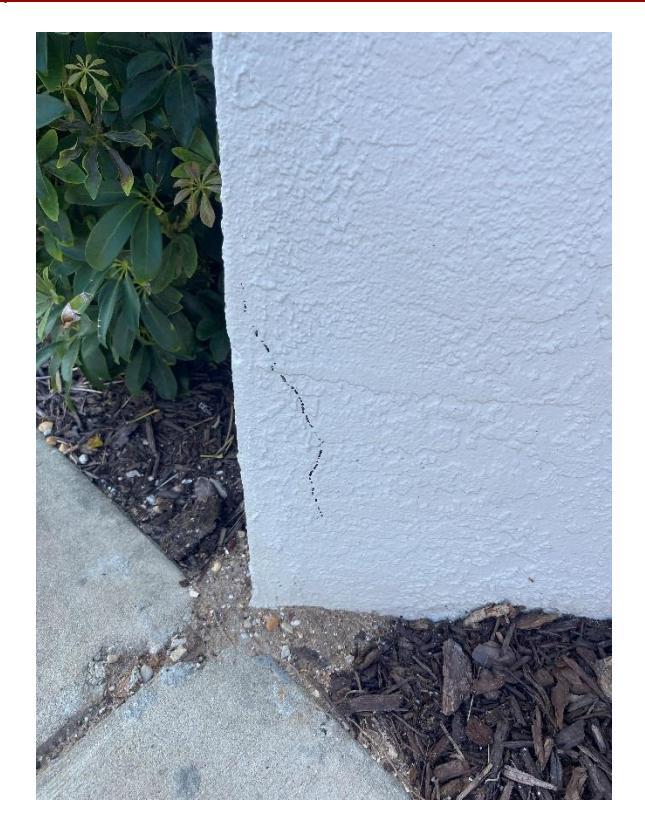
Photograph #17 – Typical wall spall at building exterior corner

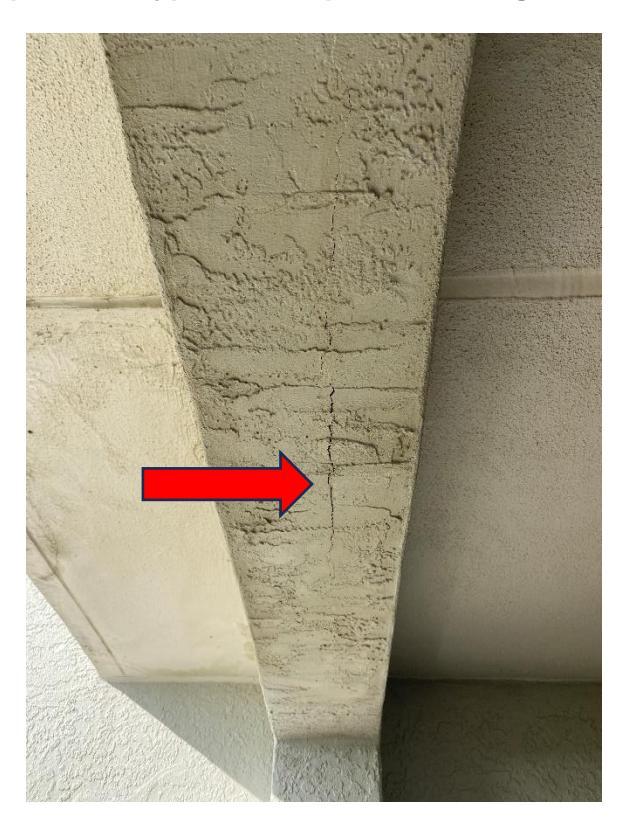
Photograph #18 – Typical beam spall near Building "F" walkway

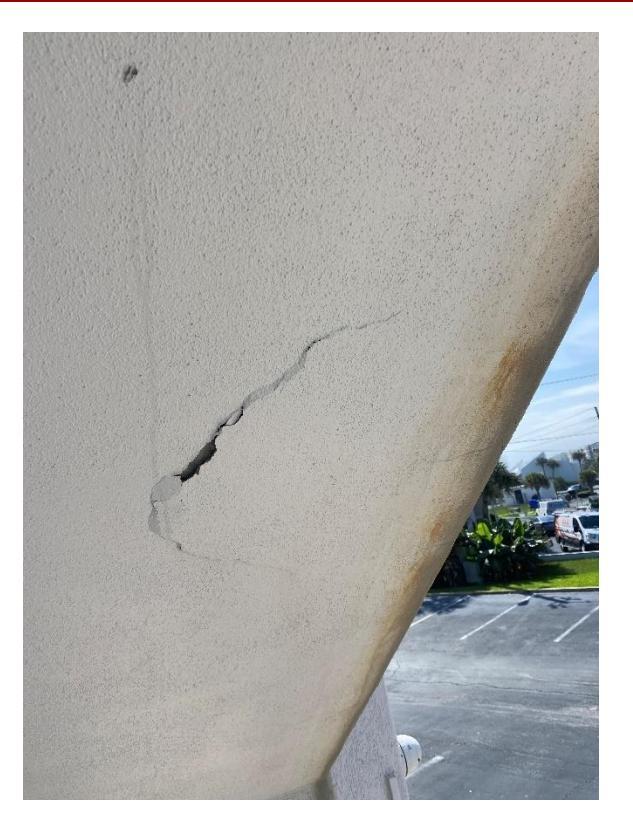
Photograph #19 – Typical overhead slab spall at walkway stair slab

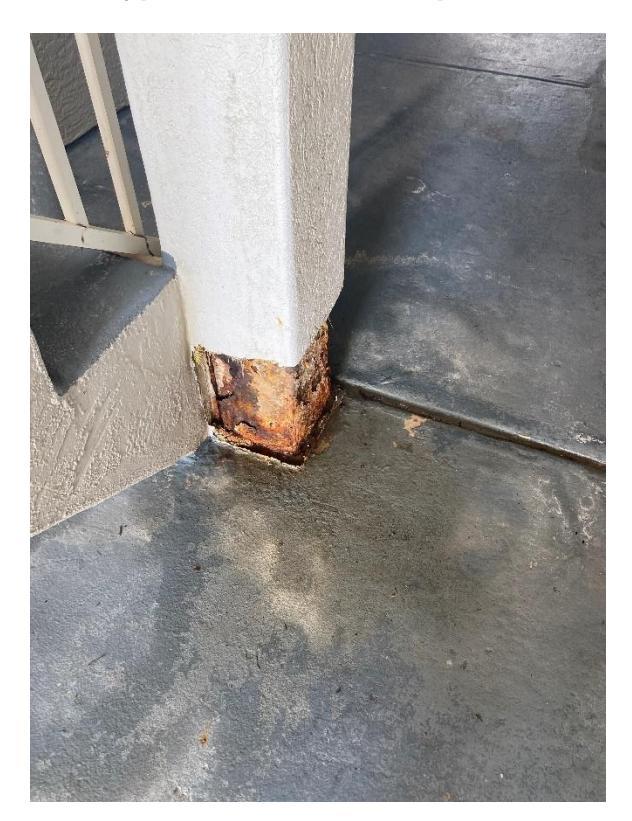
The steel columns at the stairwells are clad with EIFS (Exterior Insulating Finish System). Cracking and rust bleed was visible at several framing connections from the column to the walkway slab at Buildings "B", "C" and "D". Severe corrosion was observed on the stairwell columns between Buildings "E" and "F"; however, shoring is installed and the Owner has contracted to replace the columns.

Photograph #20 – Corroded stair column at Building "E" currently contracted to be replaced

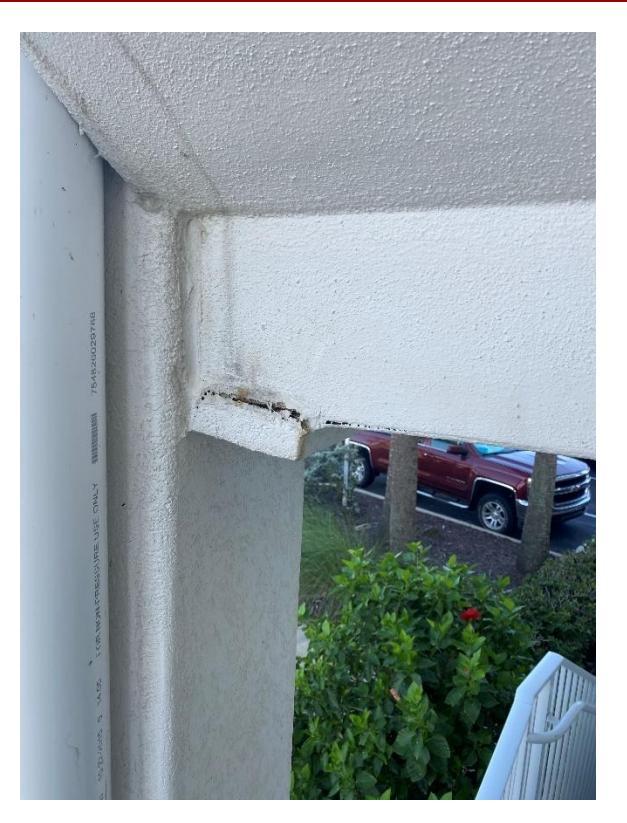
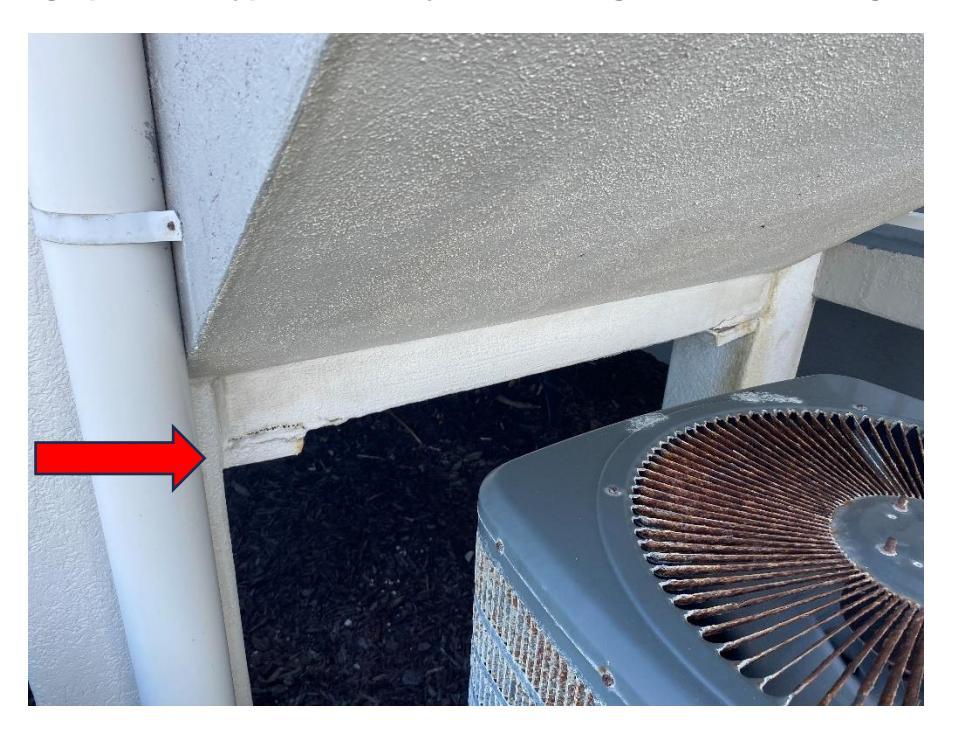
Photograph #21 – Typical walkway stair framing with cracked/bulged EIFS

Photograph #22 – Typical walkway stair framing with cracked/bulged EIFS

Based on our findings, we are in the professional engineering opinion that the building is safe to occupy once the recommended shoring is installed. A Phase II of the milestone inspection is recommended to evaluate the condition of the steel framing at the walkway stair columns that are currently exhibiting rust bleed from the EIFS finish.

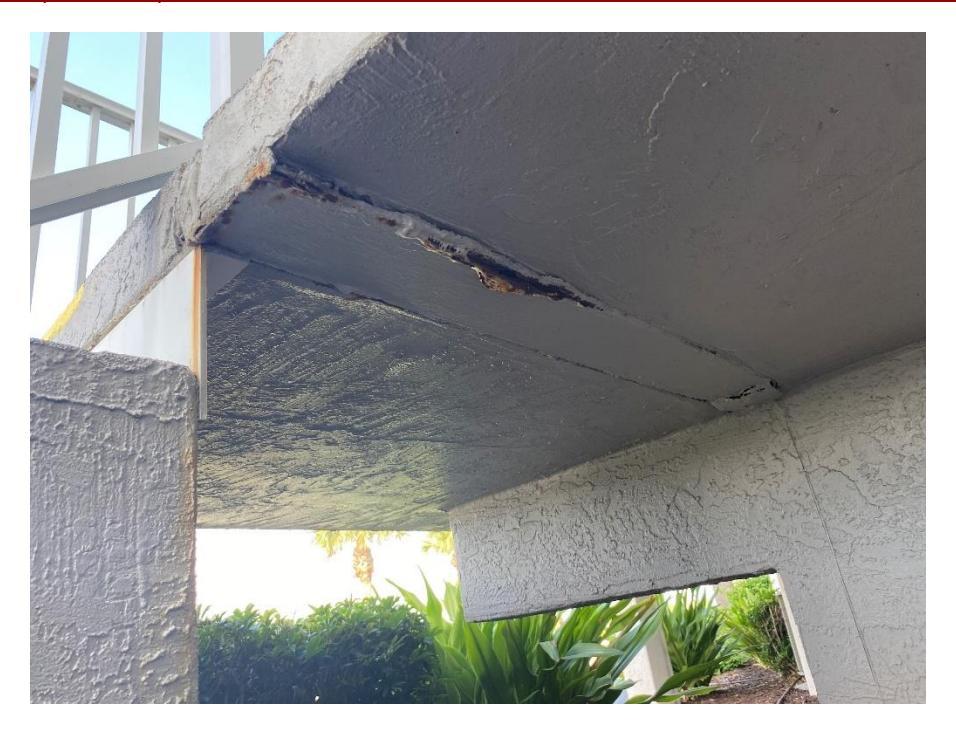
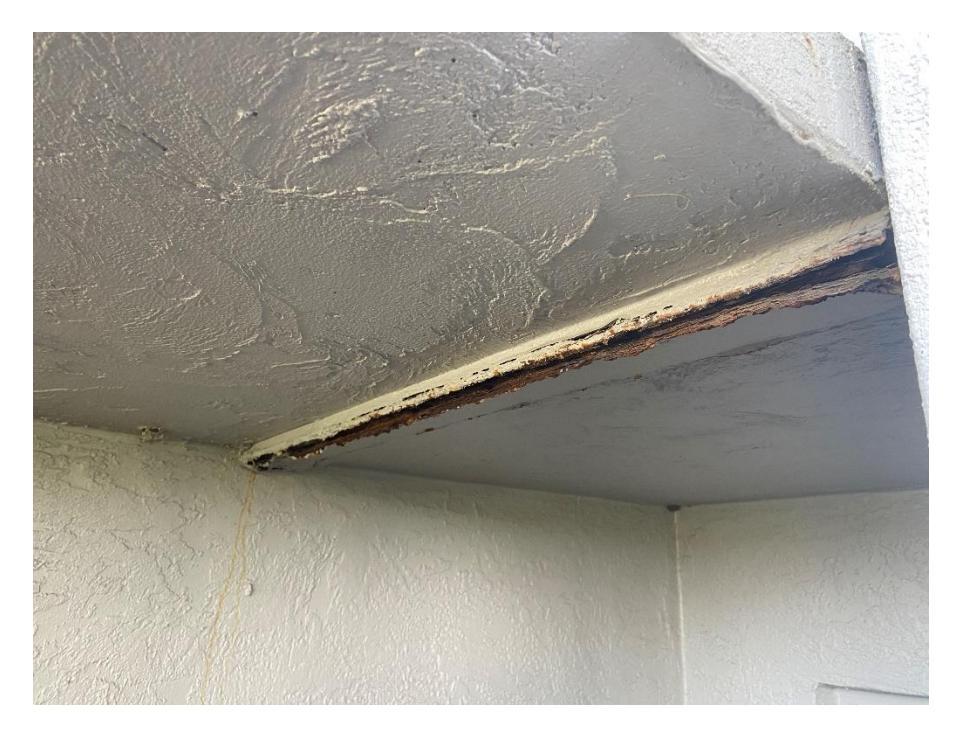
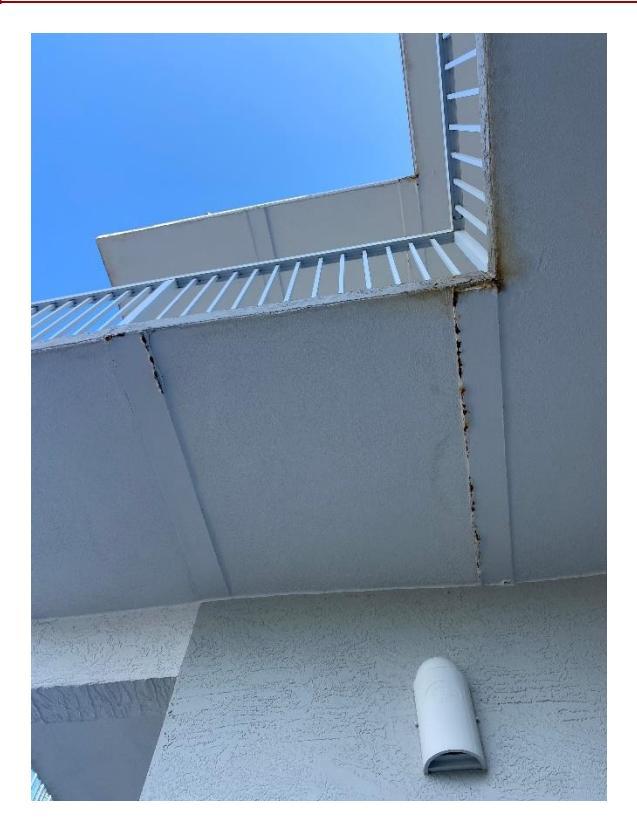
The buildings are generally in fair structural condition. <u>There was significant structural deterioration</u> <u>identified at the steel slab connections at Building "C"</u>. Corrosion deterioration was identified on structural steel angles at the walkway slabs and some stair columns. It is our understanding that the column repairs at Building "E" stairwell are contracted to be replaced. The steel angles at Building "C" should have shoring installed and repairs made immediately.

There were (10) structural steel angles at the walkway slabs of Building "C" that are severely corroded (rusting). The angles at the first floor of Building "C" between Units C101-C102 and C103-C104 are significantly deteriorated and are considered substantial damage.

Photograph #23 – Severely corroded steel slab connection at Building "C"

Photograph #24 – Severely corroded steel slab connection at Building "C"

Photograph #25 – Severely corroded steel slab connection at Building "C"

We identified evidence of substantial structural deterioration at the steel slab connections near Units C101-C102 and C103-C104. Shoring should be installed until repairs are made.

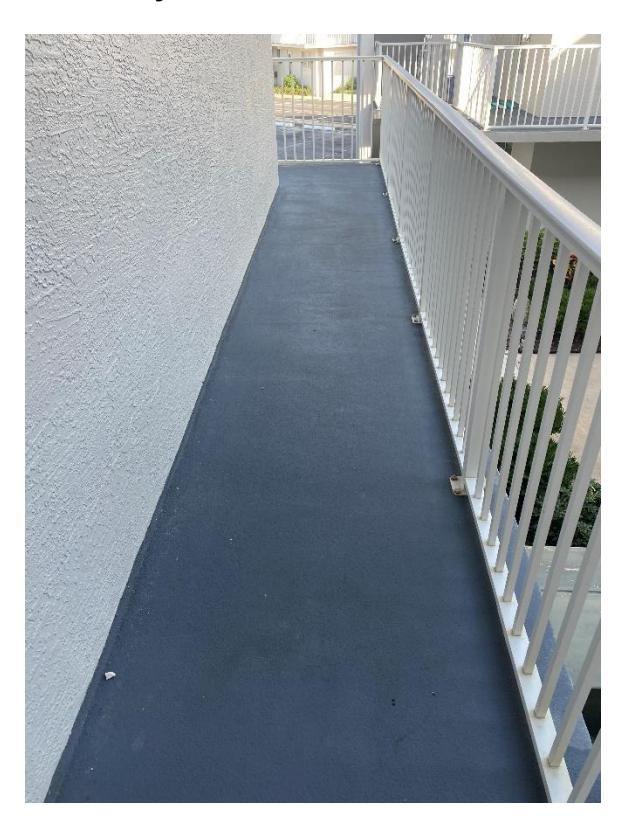
Waterproofing: The general waterproofing program is in fair condition. The waterproof deck coatings on the elevated slabs are in fair condition. The sealants around windows and doors were in varying condition. Failing sealants at sliding glass doors were observed at some units due to the oxidation of the door frame. Rusted corner bead around sliding glass door openings was common at many balconies. The vertical exterior wall surfaces generally had minimal cracking and paint blistering.

Photograph #26 – Typical exterior slab waterproof deck coatings

The sealant around windows and sliding glass doors should be replaced where they are deteriorated, missing or failing. The polyurethane deck coating on the walkway and balcony slabs should continue to be maintained. The paint manufacturer should be consulted for recommendations for painting the building. Missing and deteriorated fasteners at the guardrails should be corrected.

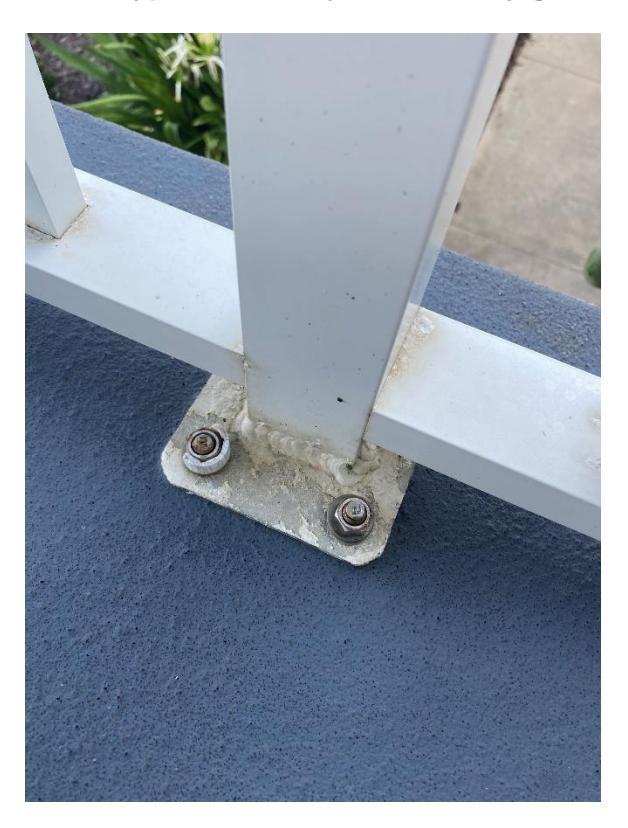
finish as manifested at many locations but the railing structure was in serviceable condition. Missing fasteners and deteriorated fasteners were common. The drive pins for the wall connections were oxidized. A few missing fasteners at Building "B" stairs and at Building "F" walkway were identified.

Photograph #28 – Typical oxidation occurring at guardrail base plate

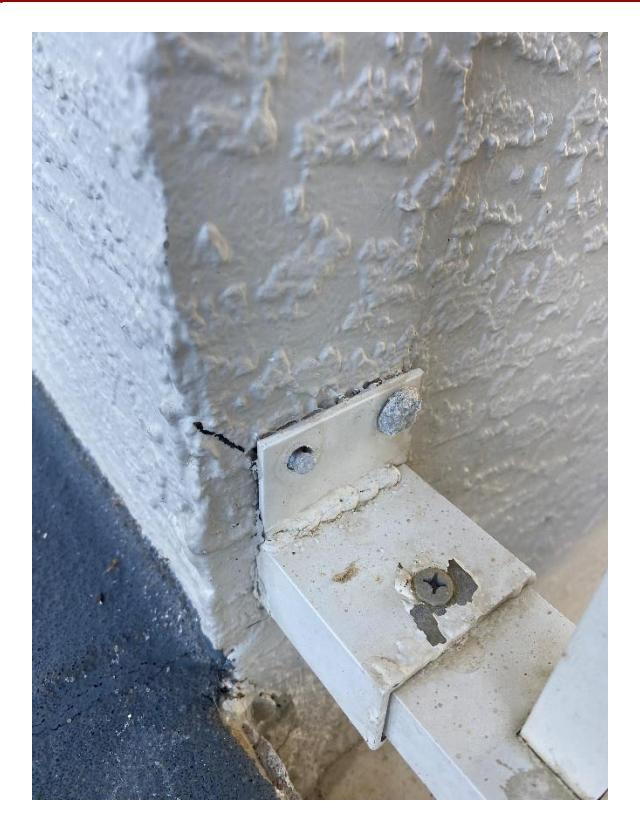
Photograph #29 – Typical corroded guardrail wall connection

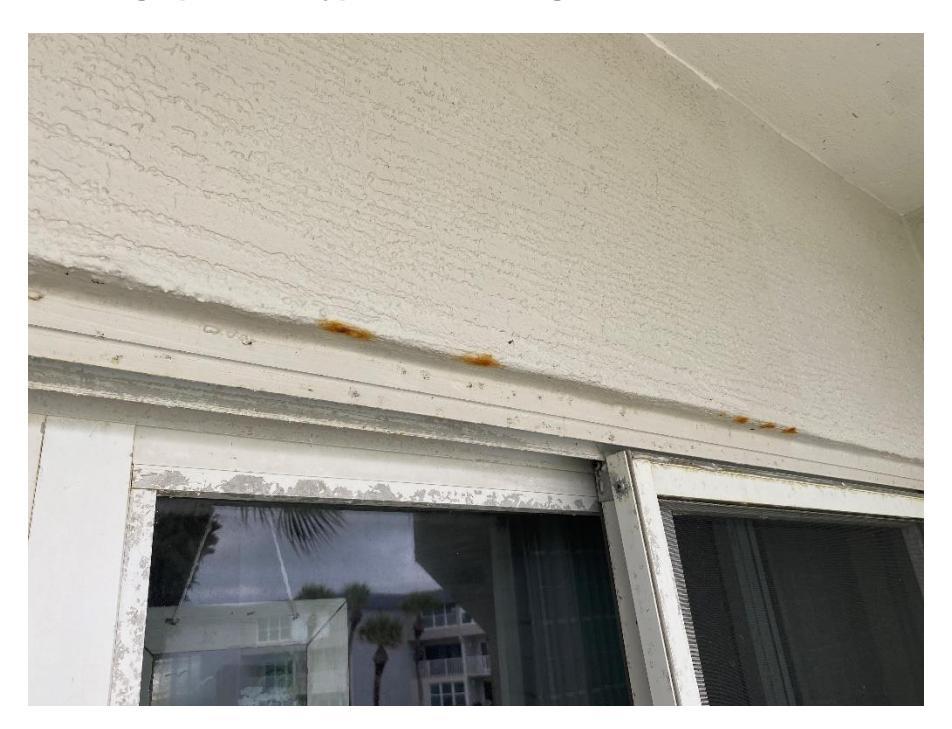
Photograph #30 – Typical rusted corner bead above balcony sliding glass door

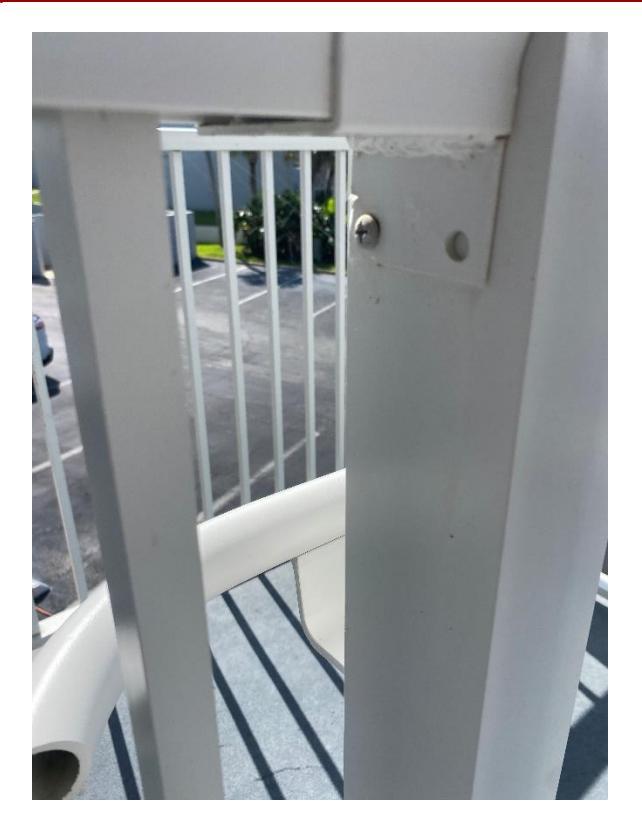
Photograph #31 – Missing screw at walkway stair guardrail
