SOUTHEASTER, INC. STRUCTURAL INTEGRITY RESERVE STUDY (SIRS)

For 30-Year Projection Period: FY 2024 through FY 2054

Reference #: 1379.24

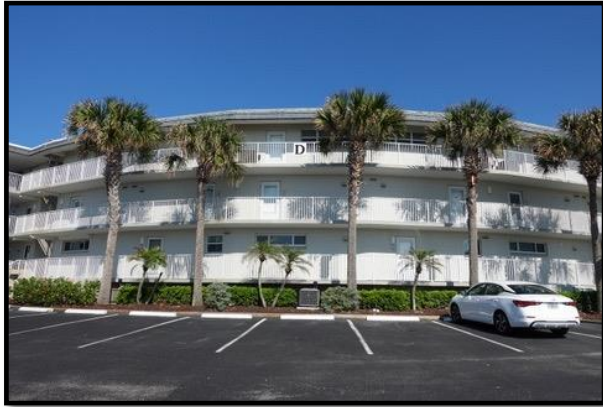
Figure 1 – Breezeway Elevation

Southeaster maintains balconies that comprise approximately 8,105 square feet of concrete surface. Balconies are structural components that support themselves rather than supporting the building. The balconies are in fair condition overall. Management reports that the Association conducted a concrete restoration in 2008. Balconies have a long useful life with the benefit of periodic maintenance. Concrete cracks and spalling occur from the expansion of the reinforcing steel bars due to corrosion. Concrete corrosion is caused by rainwater and chlorides penetrating the surface of the concrete and contacting the embedded steel reinforcement bars. Failure to maintain the balconies can lead to costly repairs.

Concrete repairs include replacing compromised reinforcing within associated cracks and spalls. Cracks should be repaired with a gravity feed epoxy. Southeaster should consider using a hybrid coating consisting of a urethane base coat with a textured acrylic topcoat. The proper way to apply coatings is to remove and reinstall the railings. Coatings provide the primary protection from the elements and can minimize ongoing cyclic structural concrete damage (spalling) due to corrosion. Waterproof coatings applied to horizontal walking surfaces should meet or exceed the minimum requirements for pedestrian traffic bearing capacity and slip resistance.

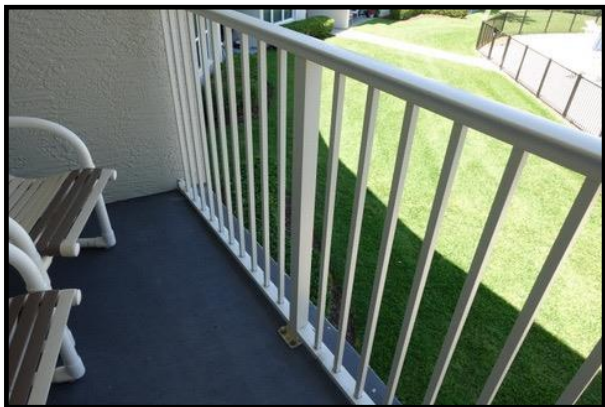
Figure 1 – Balcony Railing

The Association maintains 4,215 linear feet of aluminum railings. The finish on aluminum fences is relatively maintenance free. While aluminum doesn't rust, it does corrode over time. The railings are in fair overall condition at an age of 16 years. Aluminum railings have a useful life of up to 30 years. The major concern with railings is safety.

Southeaster can maximize the useful life by repairing connections and fasteners promptly when and if they fail. These activities should be funded through the operating budget on an as needed basis. The Association should budget for railing replacements by 2038. Surface mounted railings should be installed using stainless steel anchors set into predrilled holes and filled with sealant to minimize edge spalling. Southeaster should make sure the stainless-steel fasteners are used with caps for added protection. Areas of missing fastener caps are noted.

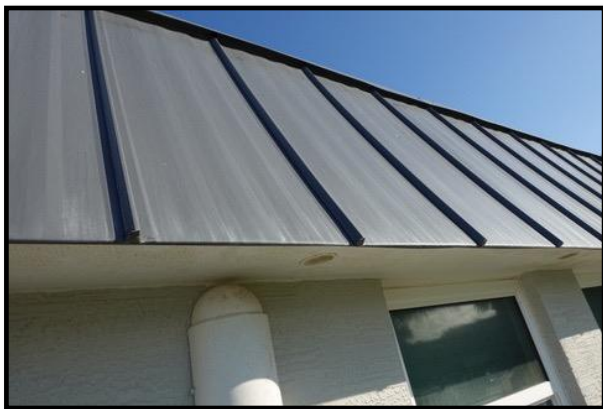
Figure 1 – New Building A Mansard

A wood framed truss mansard is installed around the perimeter of each building. There are approximately 73 squares of mansard roofs.

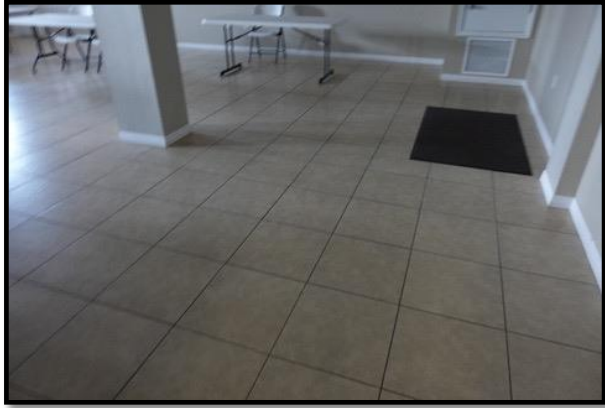
Figure 1 – Recreational Room

The Association maintains 2,770 square feet of tile floor coverings located within the recreational room and two laundry rooms. The tile floors are in good overall condition at an age of 13 years. Tile floors have an anticipated useful life of up to 30 years and beyond with the benefit of periodic maintenance. Periodic maintenance includes cleaning and partial replacements of cracked tiles as needed. Replacement is often predicated on the discretion of the active board's opinion of the need to update the appearance. Southeaster should anticipate replacement of the tile floors by 2041.

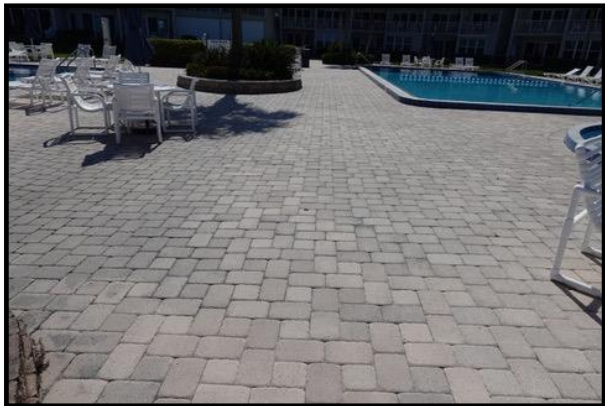
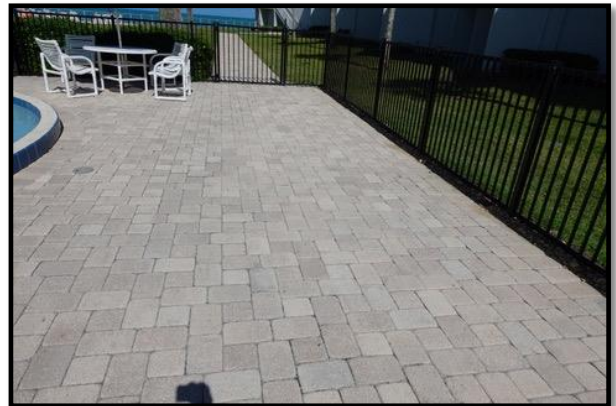
The pool deck comprises approximately 15,000 square feet of pavers. The pavers are original and in fair to good overall condition. Pool deck pavers have a useful life from 20- to 30-years with the benefit of periodic maintenance. Periodic maintenance includes pressure washing, resetting as needed and an application of sand between the pavers followed by a sealer application every three years. Southeaster should budget for replacement of the pavers by 2043 and maintenance through the operating budget as needed.

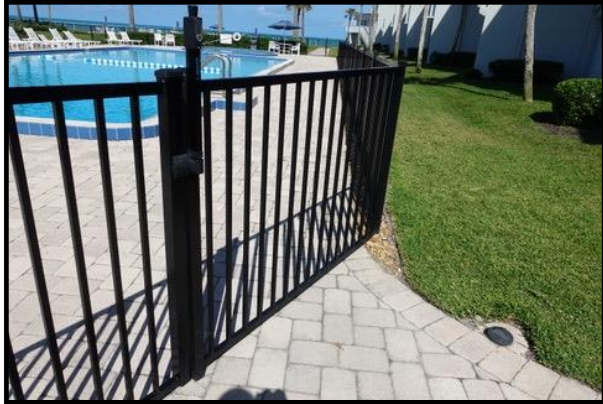
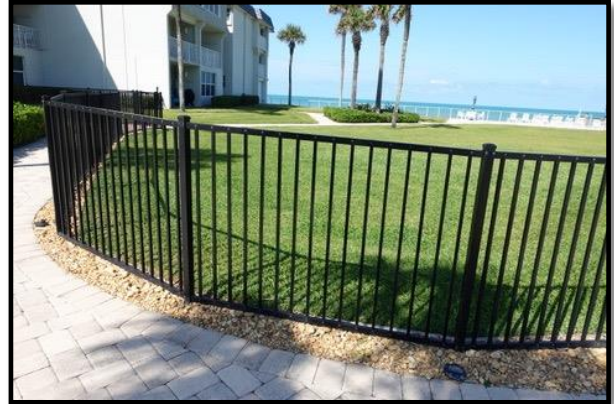
Approximately 545 linear feet of aluminum fence surrounds the pool area. This fence is in good condition at an age of one year. The finish on aluminum fences is relatively maintenance free. Aluminum fences have a useful life of up to 30 years. Southeaster should budget for replacement of the pool fence by 2053.

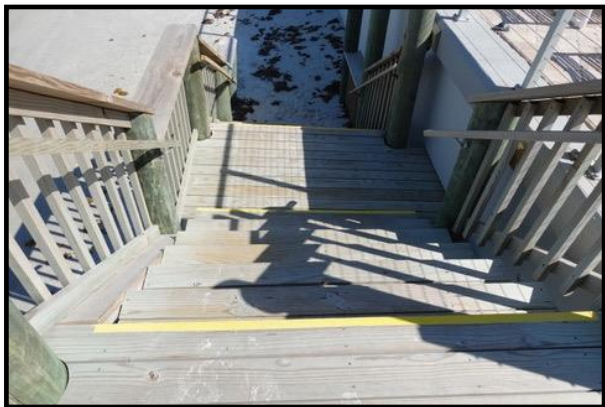
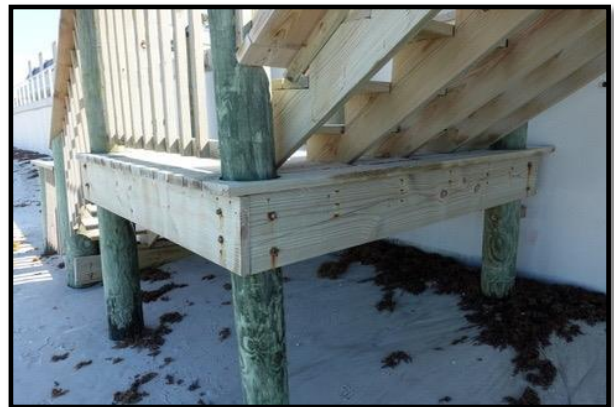
The Association maintains approximately 210 square feet of staircase decking. The staircase is in good overall condition at an age of two years. The useful life of this type of decking is up to 25 years. Southeaster should budget for replacement by 2042. Treated wood needs to dry out before applying any maintenance application. Manufacturers sometimes add a water repellent to their lumber. For fully exposed wood, a water repellent sealer or a penetrating semi-transparent stain may provide the best finishing solution. Paint and solid color stains are not appropriate.

Interim repairs and partial replacements should be funded through the operating budget as needed. The Association should fund repairs through the operating budget on an as needed basis to maximize the useful life of the pier. Repairs may include inspection for warped or loose deck boards or railing components, replacement or additional installation of connections or fasteners, and partial replacements of structural members as needed.

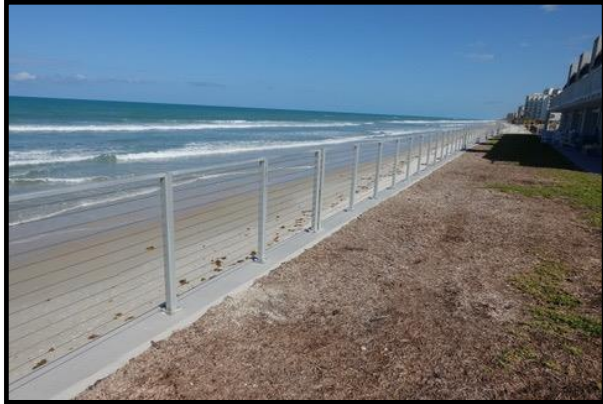
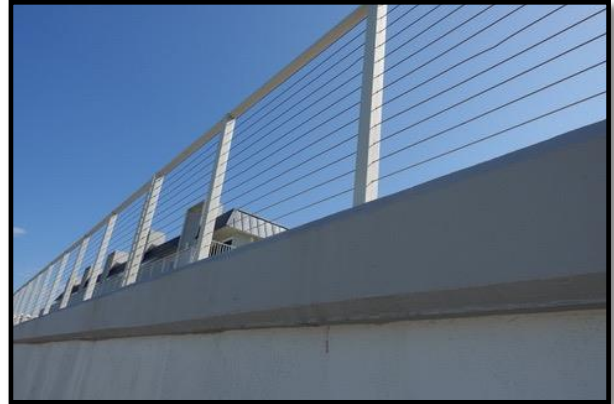
The Association maintains 445 linear feet of railings located atop the sea wall. The railings are in good condition at an age of two years. These railings have an estimated useful life of up to 30 years. The Association should budget for sea wall railing replacements by 2052 in conjunction with the sea wall.

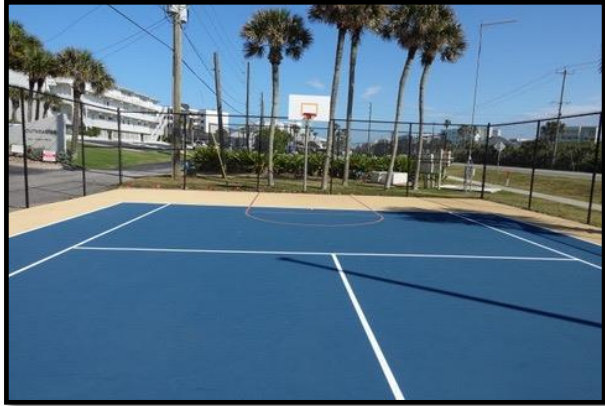
Figure 1 – Asphalt Court

The Association maintains two tennis courts that comprise a total of 1,205 square yards. One is concrete and the other is an asphalt surface. The tennis courts require repairs and a color coat application every four- to six-years to maintain the playing surface. The color coat is in fair overall condition at an age of four years. Southeaster should budget for color coat applications in 2025 and every five years thereafter except when replacement occurs.

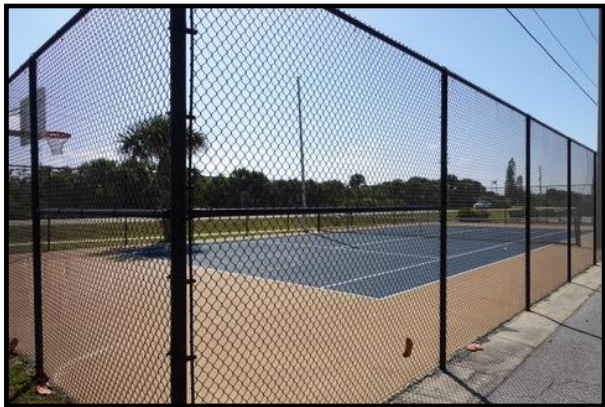
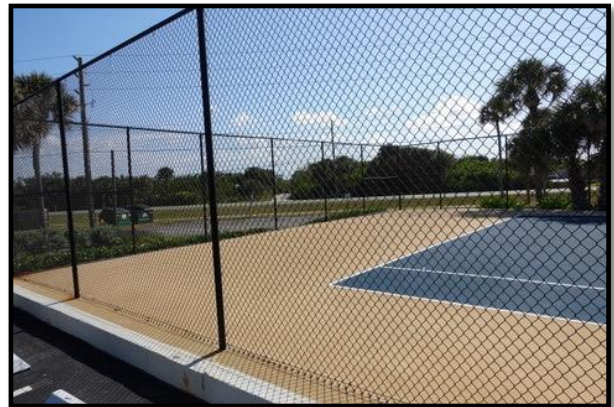
The tennis courts are enclosed by 645 linear feet of chain link fence. The fence is in good condition at an age of less than one year. The fence has a useful life of up to 30 years. Southeaster should budget for replacement by 2054.
